# Manhole Inspection Summary

Manhole # S23M1\_009MH

**Location** Address: **1500 W. Patapsco Ave.**

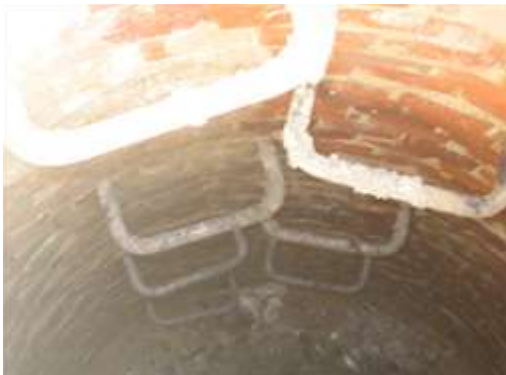
Steps

**Steps** Count: **7** Missing: **0** ☒ **Corroded**

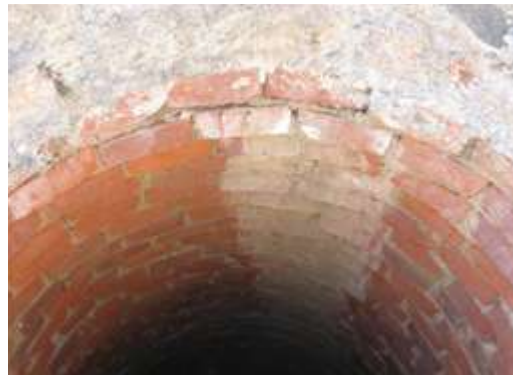
Defect 1

Infiltration: ☐ None ☒ **Joint** ☐ Cracks ☐ Mortar ☐ Roots ☐ Wall

Infiltration

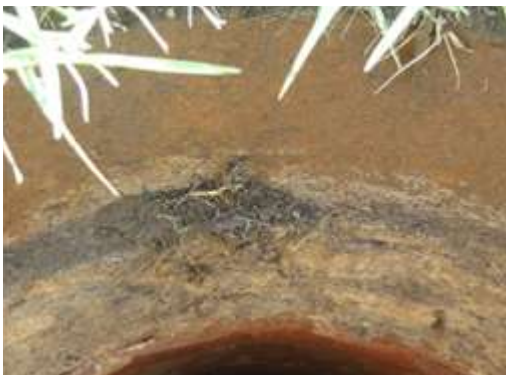
Defect 2

**Frame** Offset: **1** (in.) Condition: ☒ Sound ☐ Cracked ☐ Leaks

Frame offset.

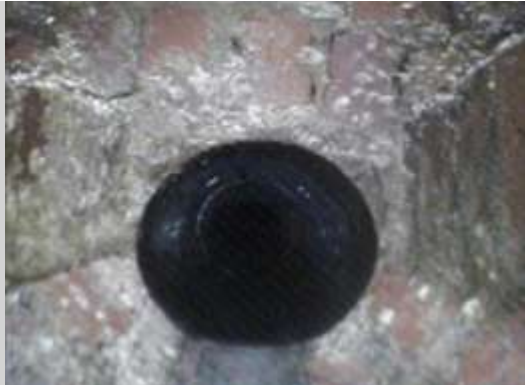
12 O'Clock Outflow

Pipe Height: **8.4** (in.) Rod and Bar (Angled)  
Pipe Material: **Clay** ☐ Pipe Lined  
Invert Depth: **14.00** (ft.) Flow Characteristics: **Slow**  
Deposits: ☒ None ☐ Mud ☐ ~~Gravy~~ ☐ Debris ☐ Grease  
Silt Depth: (in.) Deposits Extent:  
Infiltration: **None** Pipe Seal Cond: **Sound**

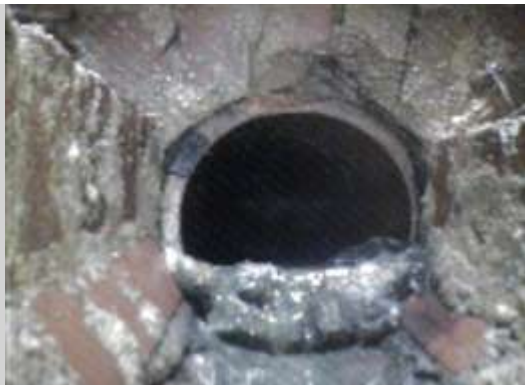
6 O'Clock Inflow

Pipe Height: **7.2** (in.) Rod and Bar (Angled)  
Pipe Material: **Clay** ☐ Pipe Lined  
Invert Depth: **13.90** (ft.) Flow Characteristics: **Slow**  
Deposits: ☐ None ☐ Mud ☒ ~~Gravy~~ ☐ Debris ☐ Grease  
Silt Depth: **2** (in.) Deposits Extent: **Light**  
Infiltration: **None** Pipe Seal Cond: **Sound**
